# Fatigue Performance Assessment of Refurbished Orthotropic Deck for a Signature Bridge under Simulated Site-Specific Loading

**Fatigue Performance Assessment of Refurbished Orthotropic Deck for  
a Signature Bridge under Simulated Site-Specific Loading**

Presented to the Graduate and Research Committee  
of Lehigh University  
in Candidacy for the Degree of  
Master of Science

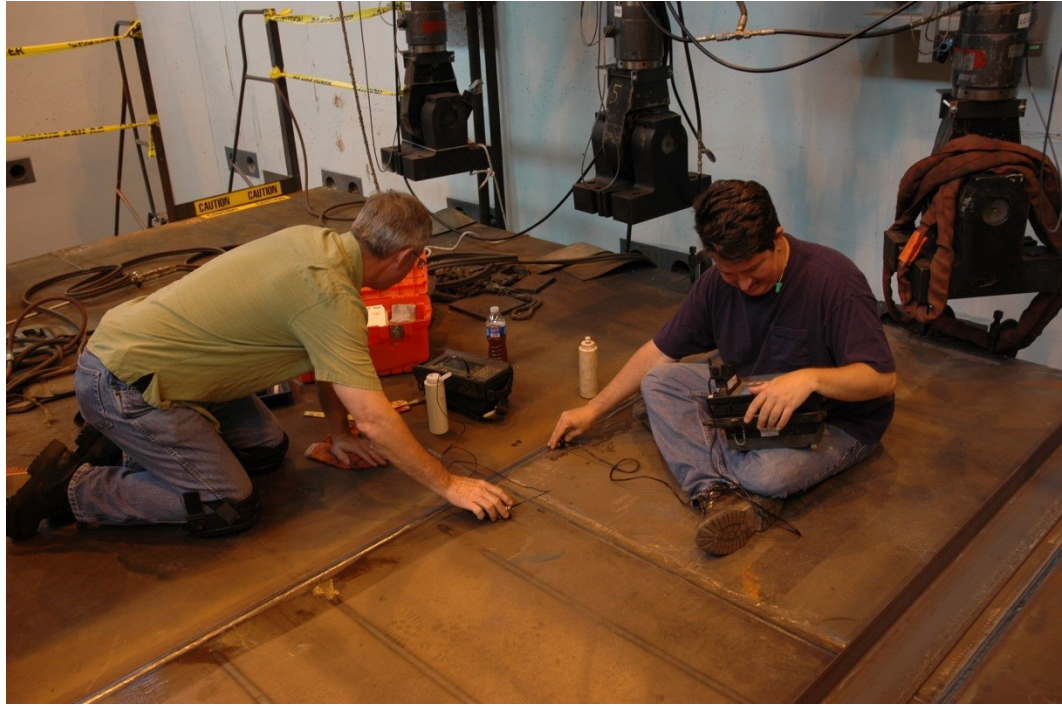
**Figure 9 Inspection of deck plate welds by UT Level II inspectors using both conventional and Phased Array Ultrasonic testing devices**

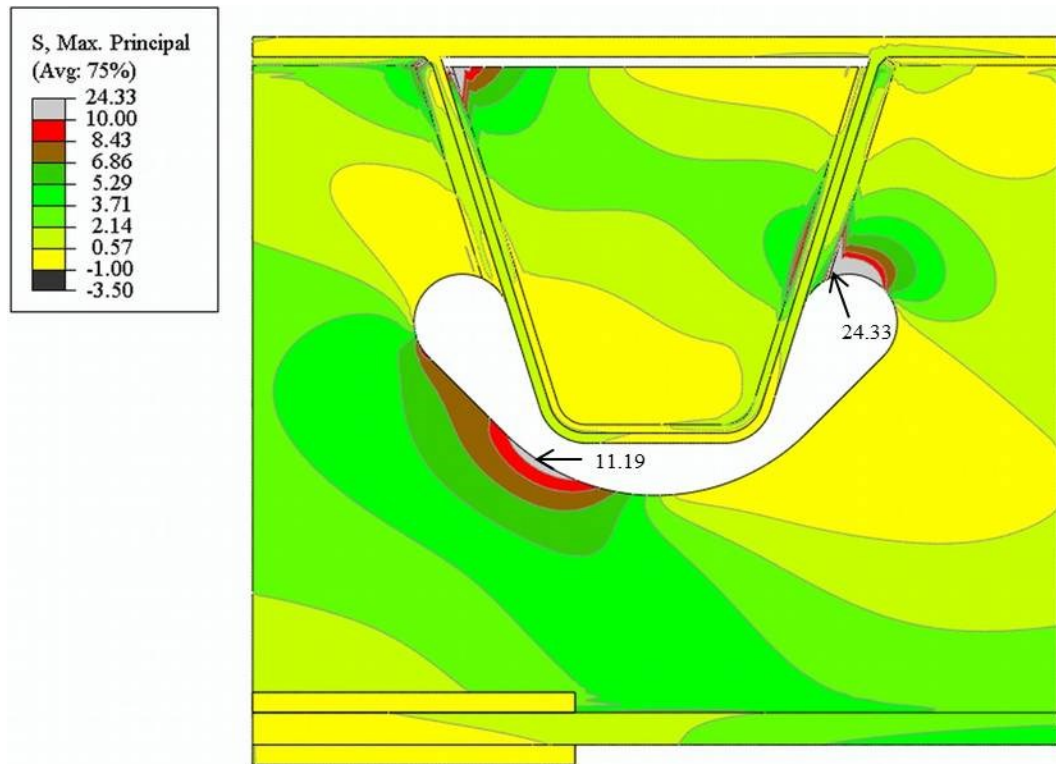
**Figure 41 Stress contour plot around rib 7 at SFB2a cutout and bulkhead plate**

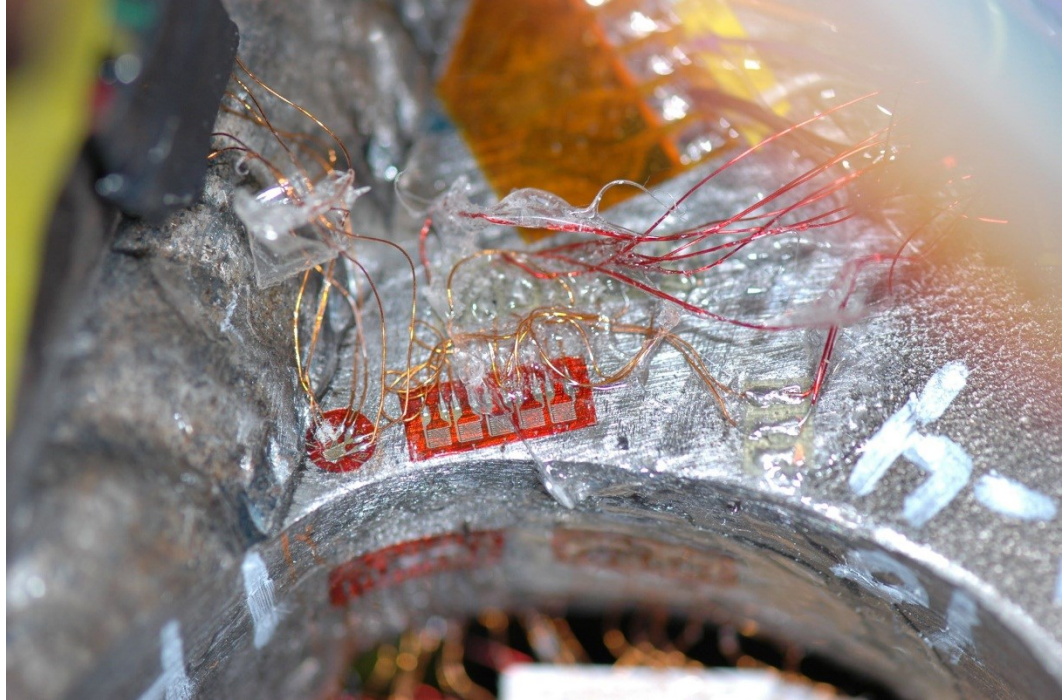
**Figure 165 Orientation of gauges at the cutout - Rib 3 south face**

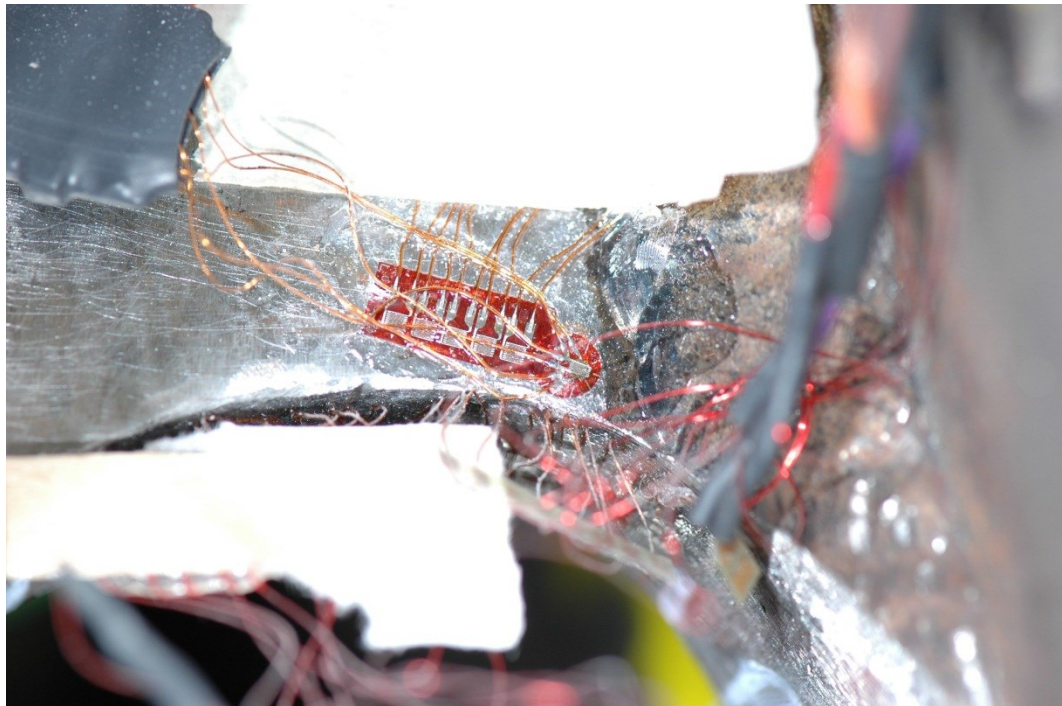
**Figure 166 Orientation of gauges at the cutout - Rib 3 north face**

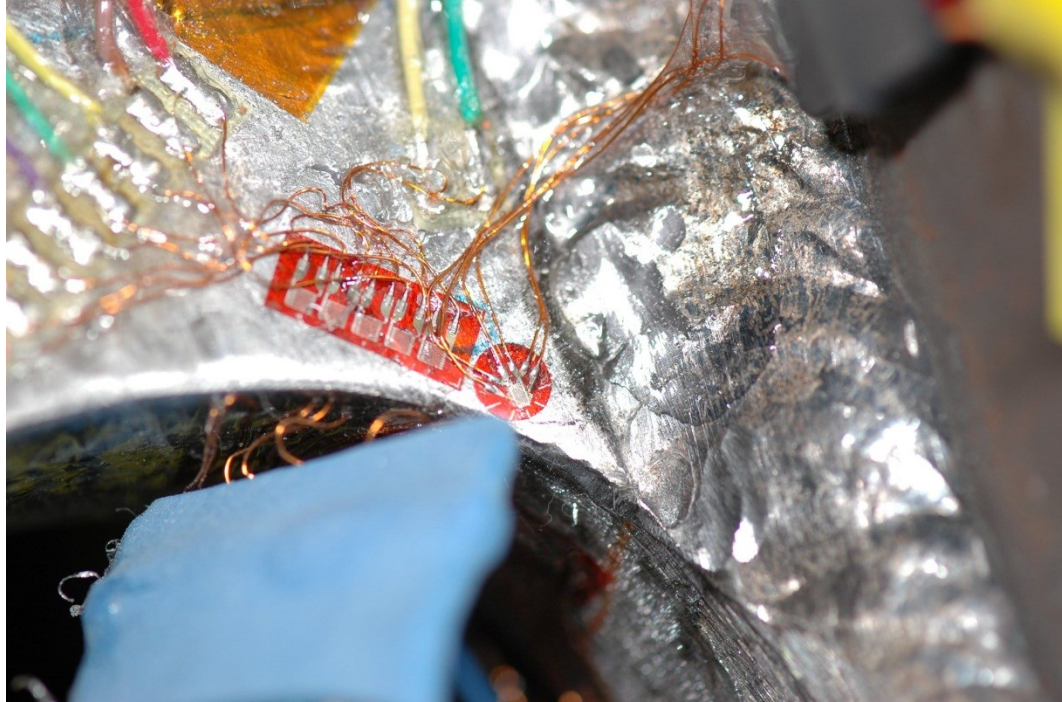
**Figure 167 Orientation of gauges at the cutout - Rib 7 south face**
